# How do you remove and prevent flash rust on stainless steel?

*N. W. Buijs – Metallurgist – Innomet b.v.*

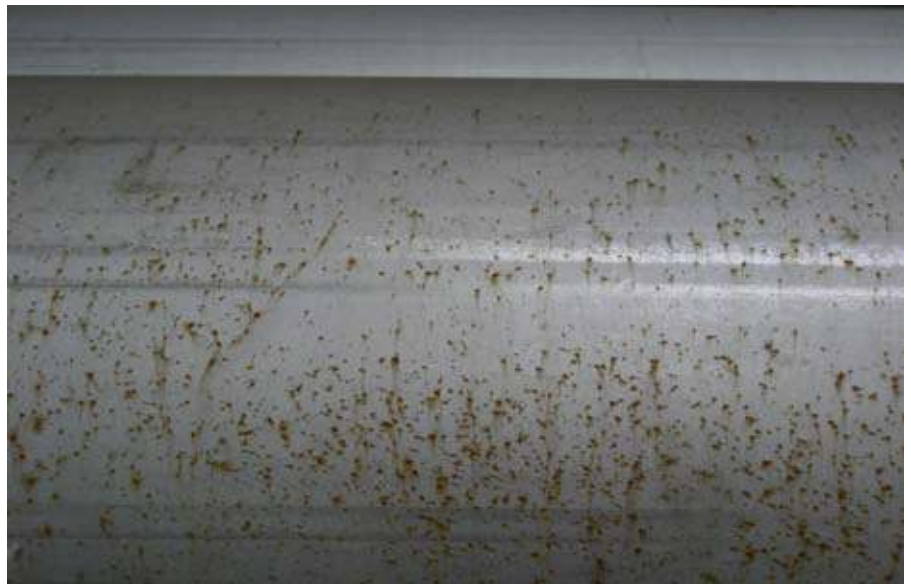
Fig. 1. contamination corrosion on stainless steel tubes caused by carbon steel grinding.

One of the causes of flash rust, also known as rust film, is when small steel particles fall or swirl down onto a stainless steel surface. When combined with moisture, they quickly dissolve due to the base character of the steel particles (see Fig. 1). There is a relatively large potential difference between stainless steel and carbon steel, which is why this reaction occurs extremely quickly. In practice, the term 'iron particles' is often used, but what is actually meant is 'steel particles'. During dissolution of the steel particles, iron oxides are created that contaminate the surface of the stainless steel. In addition, oxygen is somewhat prevented from entering the area, as a result of which the stain-

less steel surface becomes activated locally. This then leads to contamination corrosion. Examples include steel particles that are the result of wear and tear, such as near to railway tracks, as well as grinding dust and showers of sparks that develop during carbon steel grinding. The latter particles are particularly dangerous because they can burn into the stainless steel surface whilst the core of these particles still contain unburnt steel. In addition, the abrasive movements of carbon steel and stainless steel together can also lead to contamination corrosion in the end. This is why stainless steel needs to be protected from carbon steel and must be processed separately from carbon steel. If the latter is not possible than pickling and passivating stainless steel offers a good option to become free of any undesired steel particles.

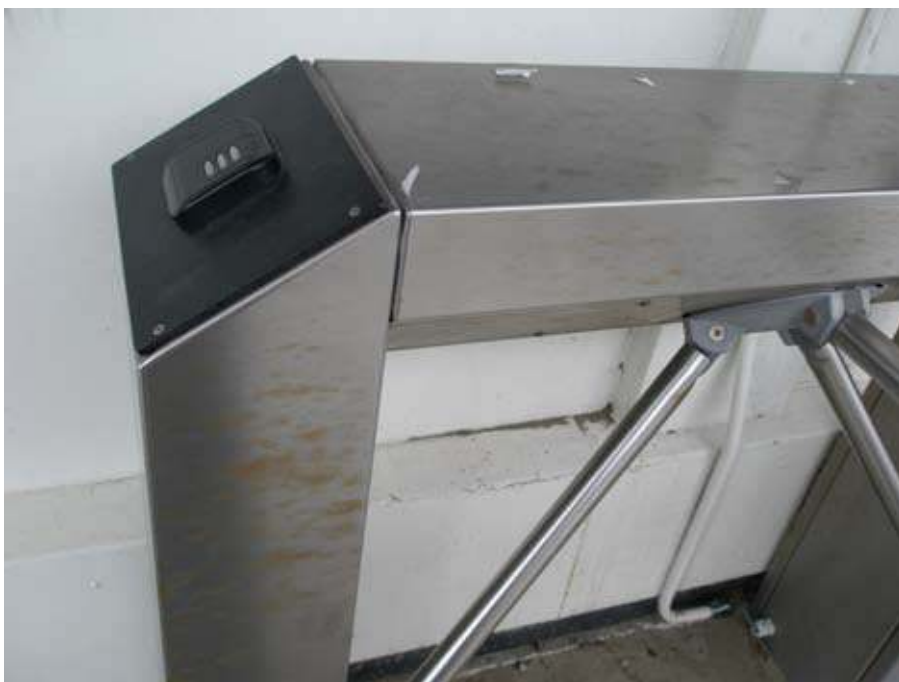
Fig. 2. RVS 316 access gate corroded by aerosols.

Local rust spots can also develop due to aerosols, for example, and this primarily occurs in coastal areas. Aerosols are small droplets of seawater that are carried from the sea by the wind and which evaporate during their flight leading to a further increase in salt and chloride concentrations. This forms a greater corrosive load for stainless steel than normal seawater. The result is local corrosion that can also even lead to pitting corrosion at times. The effect of this action can regularly be seen on stainless steel parts on or near the shore in particular. In Fig. 2 you can

see an access gate made from stainless steel 316 that is situated near to the coast. Rust spots, which in this case are also known as tea stains, can clearly be seen.

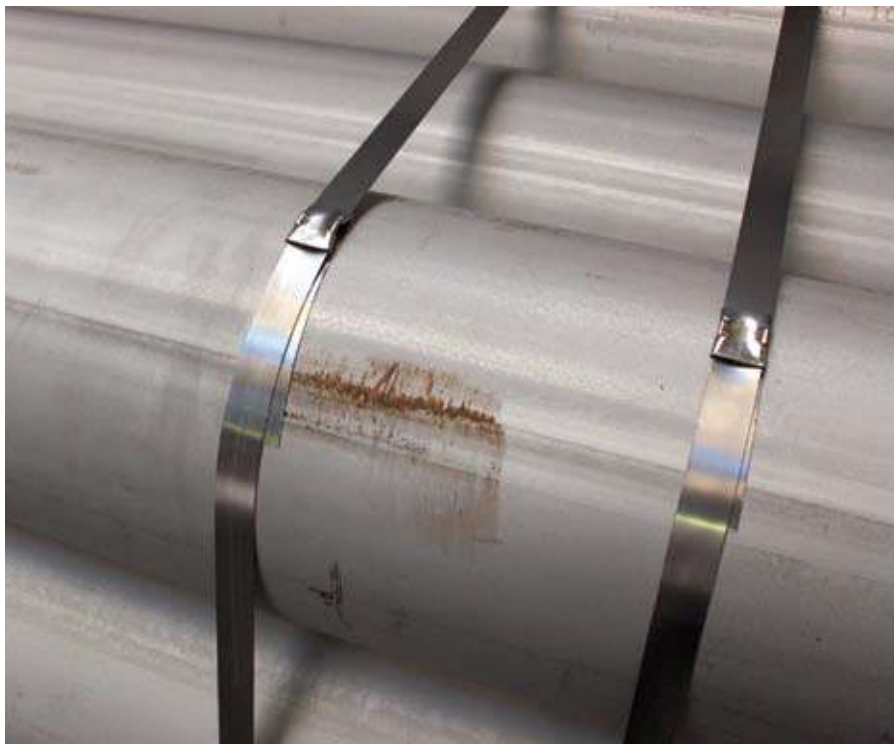
Fig. 3. Contamination by a steel object such as the fork of a forklift truck.

Another common reason for contamination corrosion is the contact between carbon steel and stainless steel due, for example, to steel forks of forklift trucks, nails on pallets, contact with Stelcon plates, steel tools, steel transport rollers etc. An example of this can be seen in Fig. 3. Corrosion prod-

ucts can clearly be seen seeping out of the 'wound', causing further contamination to the surface. If this damage is not removed then the corrosion will quickly continue in this area until the material is bored through locally as it were. The speed with which it happens is due to the fact that contact occurs between a small anode and a large cathode.

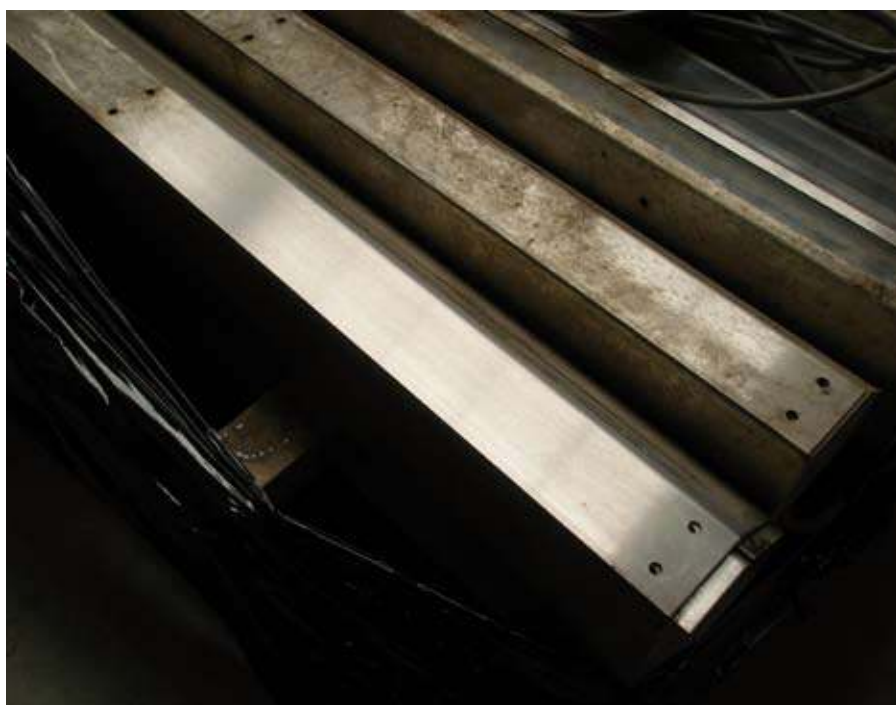
Fig. 4. Contamination corrosion on 316L light fittings (the bottom fitting has partially been treated with the organic acid Innosoft B570).

Local rust formation can be removed with pickling liquids or pickling pastes as well as with inorganic chemicals. In some cases this can also be done mechanically with, for example, sandpaper, special scourers or stainless steel brushes. The disadvantages are generally well-known, as scouring damages the surface considerably and, in addition, the scoured area is often less corrosion-resistant. Pickling is harmful to the environment and dangerous for the people working with it. Regular inhalation of the hydrogen fluoride present can even lead to a pulmonary embolism. The use of inorganic acids also has its dangers and is also subject to stringent rules and guidelines. This is why an oxide-dissolving organic agent called Innosoft B570 is now available that gives a very effective and efficient result. In Fig. 4 you can see light fittings made from stainless steel 316 that were only in use in a maritime environment for one and a half years. The top sections still show the severity of this contamination by aerosols. After use of the organic acid Innosoft B570, the surface was quickly restored to its original condition. The bottom fitting has partially been treated with this. And yet one must not lose sight of the fact that small scars may have developed in the surface that could quickly lead to new corrosion as soon as the fit-

tings are put back in place. This is why a basic neutraliser has been developed that also deposits a nanolayer on the surface to provide protection against possible new corrosion. This product will be introduced on the market under the name Innoclean B560. A maintenance protocol will also be needed in this case as all things come to an end. In other words, the surface will need to be cleaned and the nanolayer reapplied periodically.

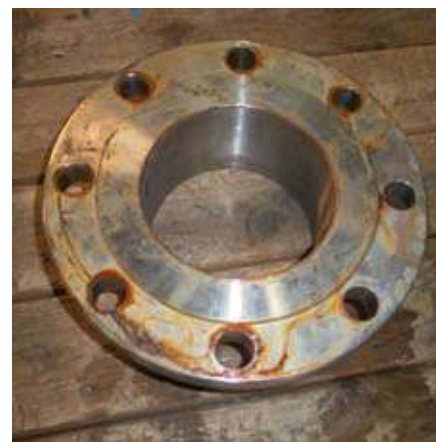
Fig. 5. RVS 304 flange contaminated by ferruginous water.

Various maintenance advice can be found on the Internet regarding stainless steel. Unfortunately, reputable companies sometimes issue advice that is often at odds with what should actually be done. For example, advice is given to clean contaminated stainless steel with steel wool or a scouring sponge. This should particularly be avoided as steel wool is something that contaminates stainless steel and a scouring sponge damages the surface. This is why Innosoft B570 is a product that only dissolves the iron oxides and also has a deep cleansing effect. In other words, it is gentle on stainless steel but tough on oxides and all kinds of dirt. A good example can be seen in Figs. 5 and 6. A stainless steel flange 304 was kept in a plastic bag in which ferruginous water was present. The flange came out the packaging in such a state that it was ready for the scrapheap. This problem was easy to solve with the afore-mentioned organic cleaner and the flange was recondi-

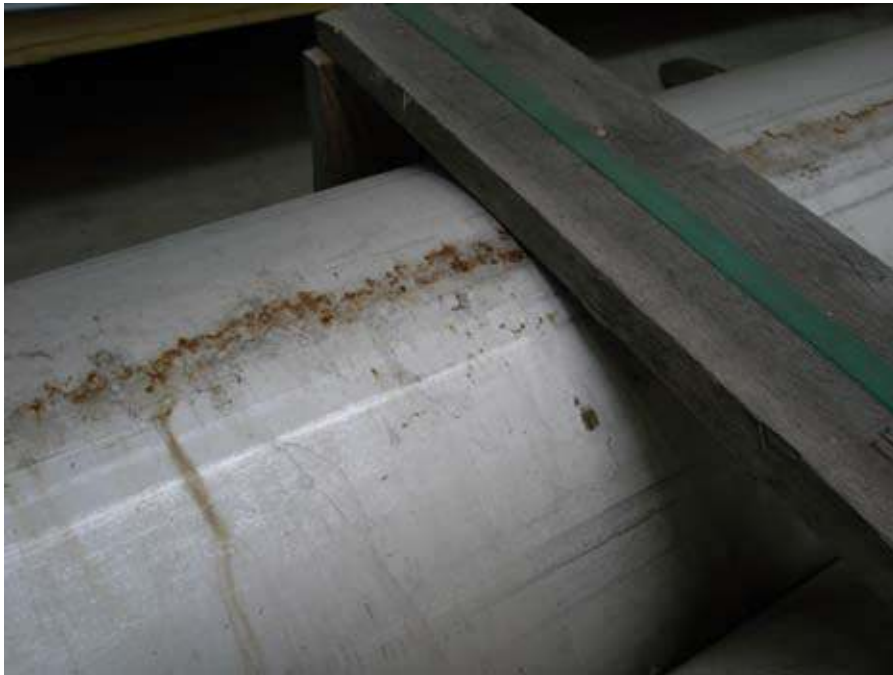
Fig. 7. Stainless steel 316 tube that was badly contaminated by steel grit on a building site.

Another example is a seriously contaminated stainless steel tube that was lying at a building site (see Figs. 7 and 8). A section on the left of the bar was the only part treated with this particular organic acid and the result exceeded all expectations.

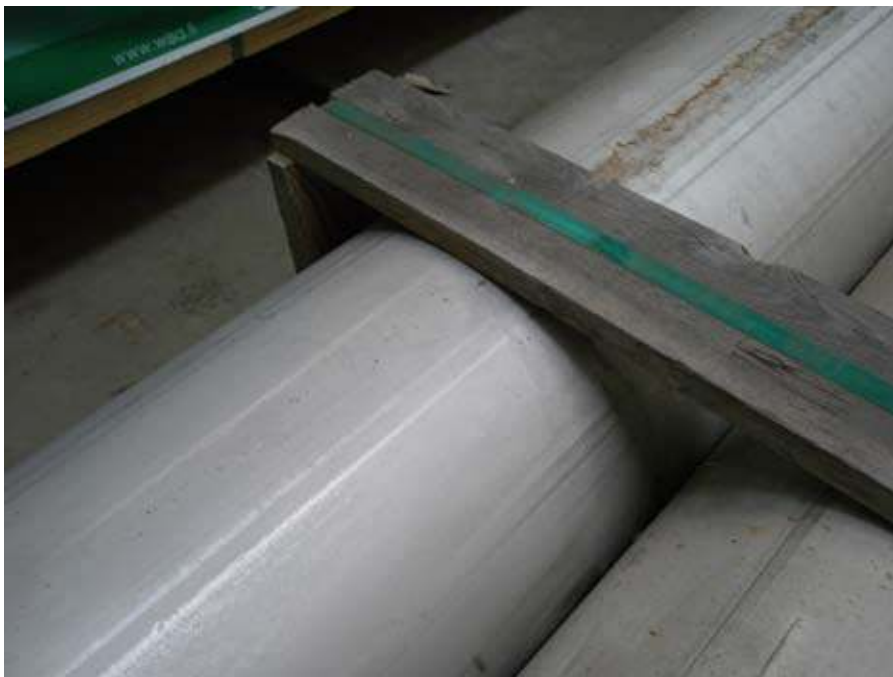
Fig. 8. The same tube as in Fig. 7 but cleaned on the left side of the bar.

It would be sensible to mention that corrosion pits will of course remain, but the pits are, however, stripped of the harmful corrosion products. These imperfections do require extra care as they can quickly set the corrosion mechanism in motion again. In that case, the invisible nanolayer also provides some additional protection.

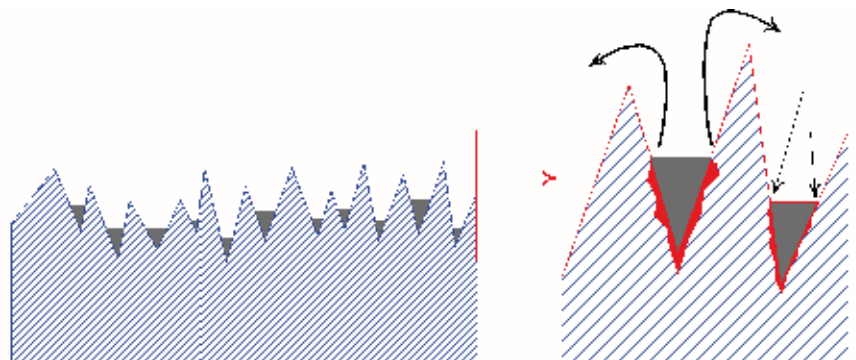
Fig. 9. Ground surface that has been significantly enlarged in the diagram. Dirt and other deposits ensure that chlorine ions, for example, are able to penetrate deeply underneath these depositions leading to local corrosion of the surface. Corrosion products such as rust will then appear.

Innosoft B570 also has a deep cleansing effect and this is of significant importance as dirt etc. can settle as a deposit, particularly on a somewhat rougher or ground surface. This can lead to 'under deposit attack' which is a form of corrosion that only occurs under these types of depositions. This type of corrosion mainly appears when aeration does not occur evenly across the metal

devastating work, whilst oxygen is scarcely able or unable to reach this particular surface to maintain its passivity. InnoSoft B570 penetrates deep down into the pores, however, in order to remove these harmful dirt deposits. This is why this product also acts as a detergent, and dirt and micro-organisms in so-called 'hidden pockets' (that can be found in the surface) are also likely to disappear.

surface. This can lead to the formation of local corrosion cells. The corrosion that occurs then concentrates on these areas (see Fig. 9). In practice, there is a known case regarding polished AISI 316 tubes on a seaworthy yacht that remained in good condition for years, but when the owner had these replaced with ground 316 tubes, the new tubes started to turn brown after only three months. This is due to the dirt deposits in the ground grooves and especially also to chlorine ions, which in terms of size are significantly smaller than large oxygen molecules. This enables chloride ions (halogens) to do their
