## FIRE SYSTEM AND PIPELINE CORROSION DANGER

# Microbiologically Induced Corrosion

WORDS BY KO BUIJS, INNOMET B.V.

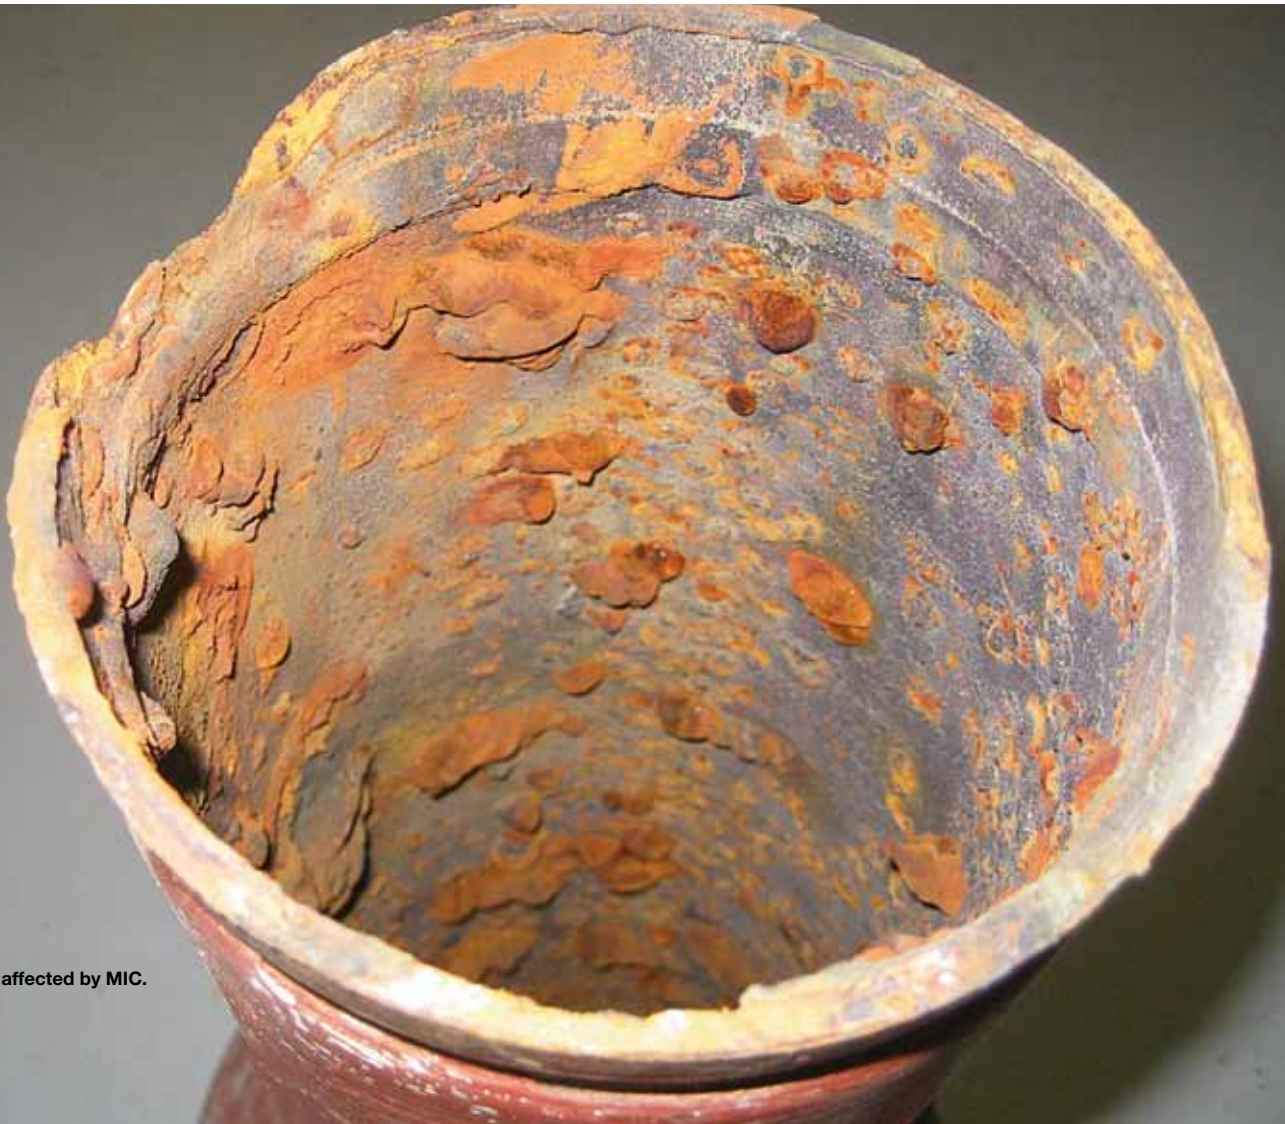
Steel pipe affected by MIC.

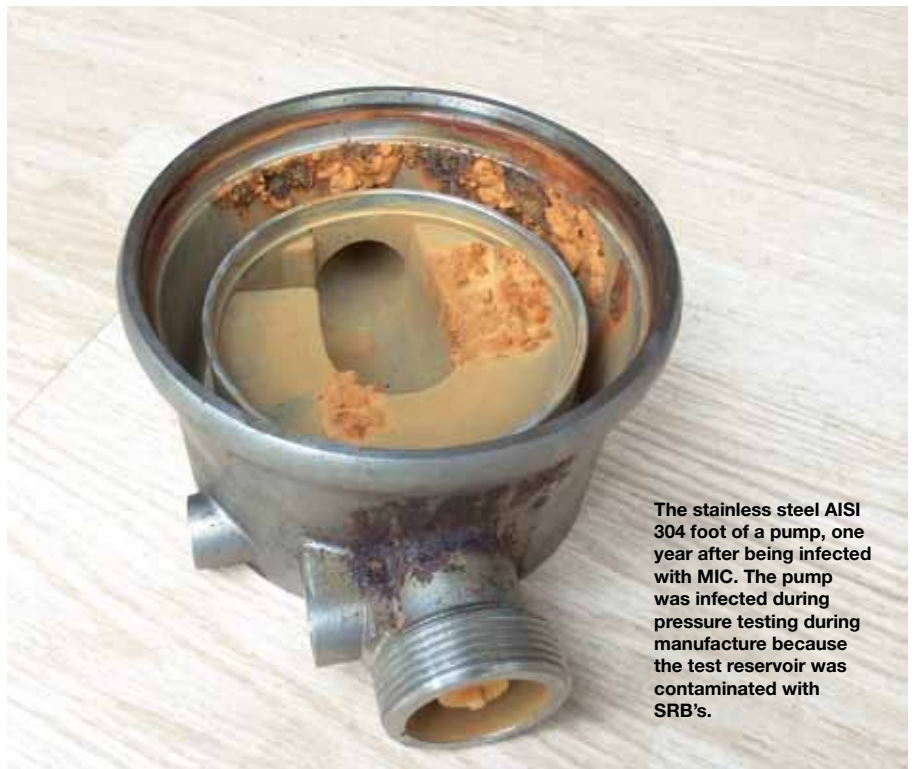
The stainless steel AISI 304 foot of a pump, one year after being infected with MIC. The pump was infected during pressure testing during manufacture because the test reservoir was contaminated with SRB's.
